Arkema Inc. Crosby Plant

Response to Hurricane Harvey

Daily Summary Report

Report Date: September 2, 2017

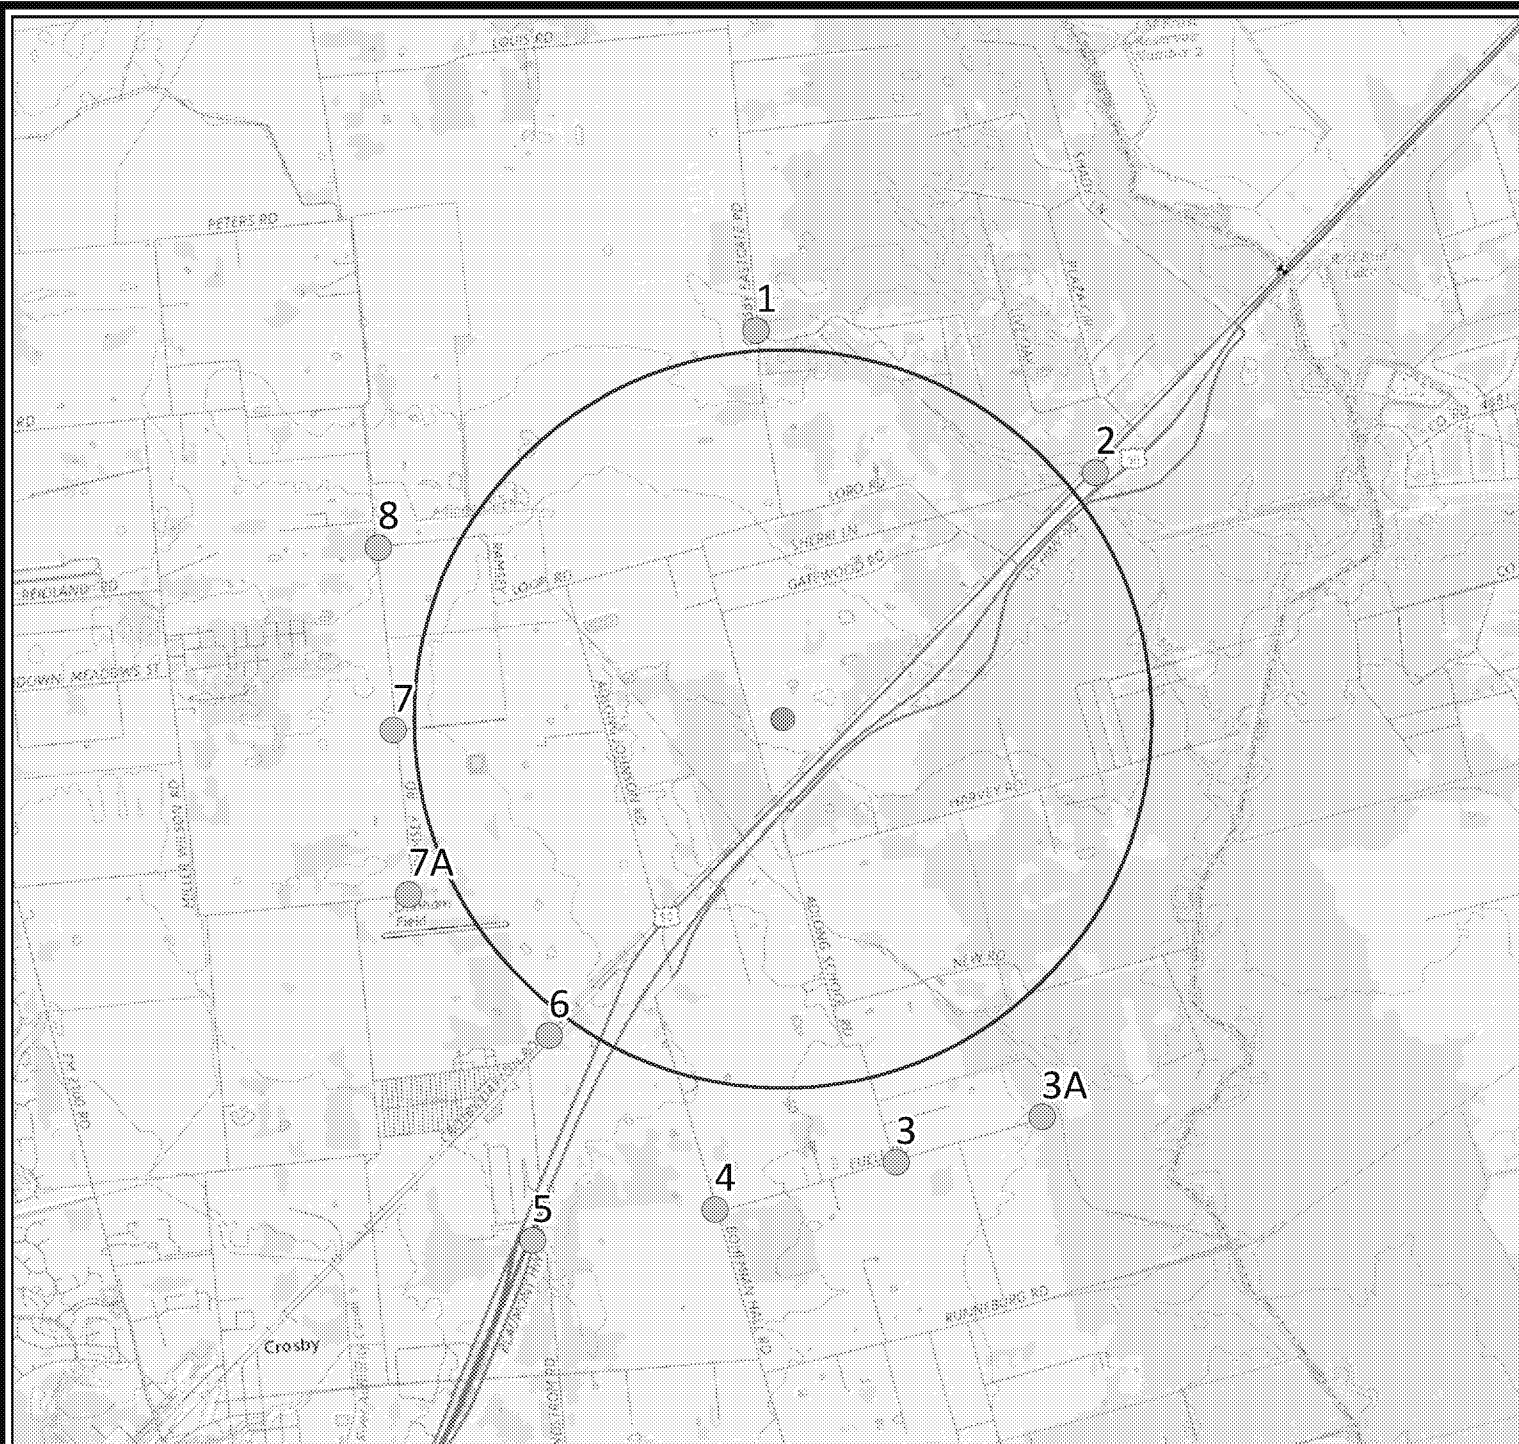
Attachment A
Site Location Map

On Wednesday August 30, 2017 Bureau Veritas North America, Inc. (BVNA) was retained by Arkema Inc. to collect perimeter air monitoring and sampling measurements. This report summarizes the sampling conducted from August 31 to the morning of September 2, 2017. Mapping of the locations are noted below.

Handheld, real-time air monitoring was conducted for volatile organic compounds (VOCs) and benzene using RAE Systems UltraRAE instruments (see Table 1). Additionally, levels of particulate matter (PM_{10µm}) were monitored using TSI Dustrak monitors. Sampling locations are shown in Attachment A.
